# The influence of surface imperfections on phosphate coating performance of nodular cast iron substrates

Samuel A. Awe

Research and Development Department, Automotive Components Floby, SE-52151 Floby, Sweden; Samuel.awe@acfloby.com

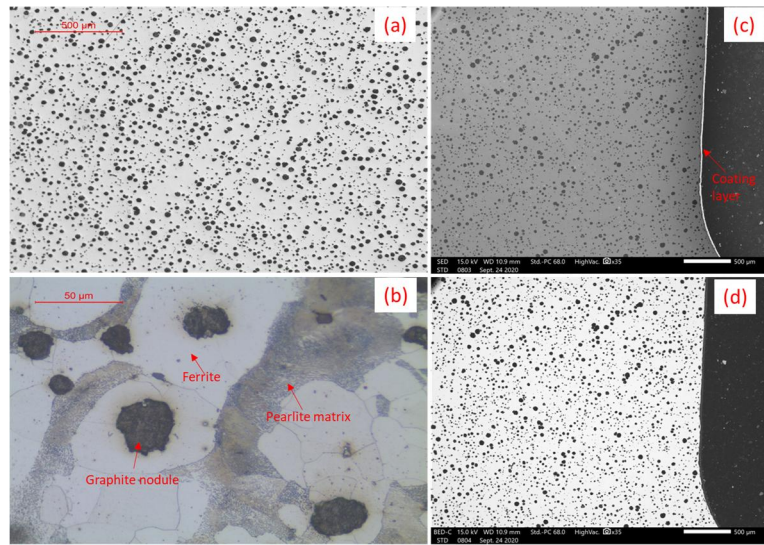
**Figure 4** depicts the substrate's optical images and scanning electron micrographs. It can be seen from **Figures 4a** and **b** that the substrate consists of graphite nodules with a size less than and equal to 6. The graphite nodules are surrounded by ferrite and the matrix is mainly pearlite.

**Figure 4.** Optical micrographs of the substrate: (a) unetched, (b) etched, and SEM micrographs of electro-coated substrate cross-section (c) secondary electron and (d) backscattered image.

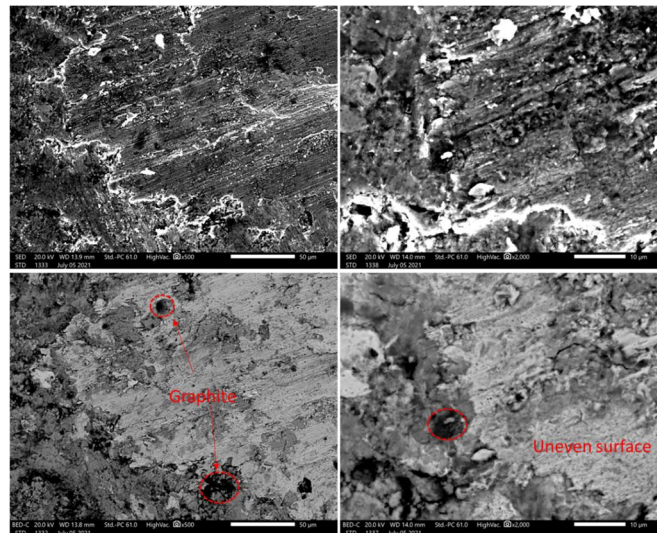
**Figure 5.** Micrographs of the unmachined surface of the cast iron substrate.

as-cast skin of the substrate while **Figure 6** provides the micrographs of the machined surface. It is apparent from **Figure 5** that the topography of the as-cast surface is uneven with different structural contrast. The surface of the as-cast substrate looks rougher than the machined one with some microcracks. The machined surface looks smoother, but cracks and rough surfaces were noted in some areas during the machining operation as seen in **Figure 6**. The graphite nodules are also observable on the machined and unmachined surfaces (the circled dark spots in **Figures 5** and **6**). Examination of **Figure 7** reveals that the as-cast surface contains different oxide compounds which include aluminium oxide, magnesium oxide, silicon oxide, iron oxide, and graphite. But in the machined surface, only Fe, Si, and C are detected (**Figure 8**). Some of these notable features and compounds may affect the deposition of phosphate coating on the substrate.

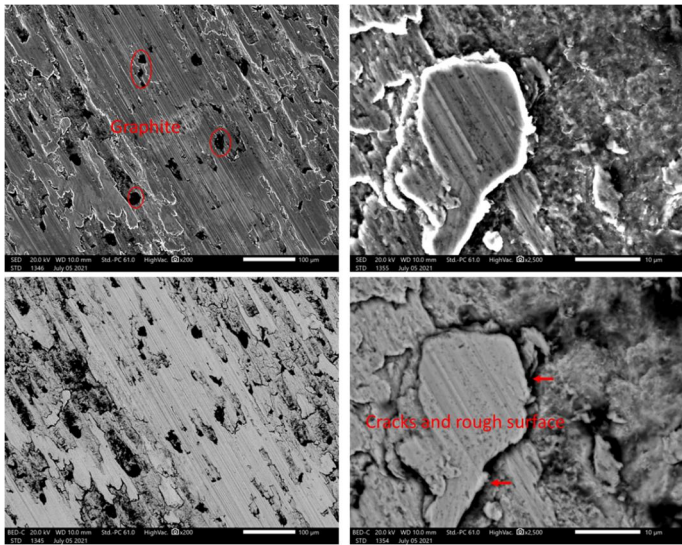
Figure 6. Micrographs of the machined surface of the cast iron substrate.

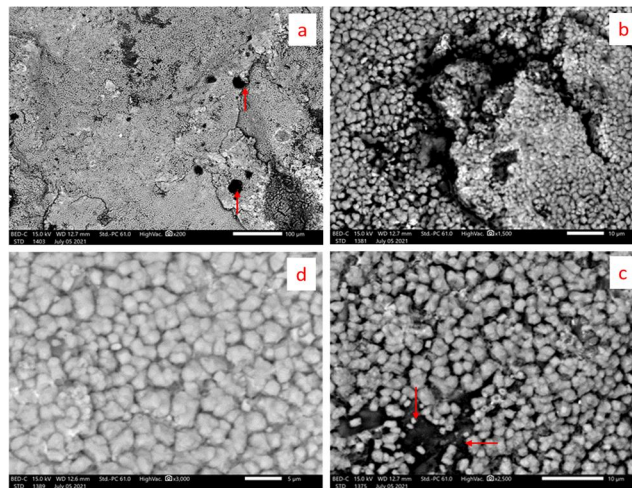
**Figures 9** and **10** show the SEM images of the phosphate-coated unmachined and machined nodular cast iron substrates, respectively. **Figure 9a** and **c** reveals some unmachined areas without coating, which the arrows indicate. Cracks are also noticed on the coated surface (**Figure 9a** and **b**). Similarly, from **Figure 10**, some uncoated regions are seen which are indicated by the arrows and broken circles (**Figure 10a** and **b**). Some rough coating areas are noticed in **Figure 10c**, which coincide with the machined surface with cracks and roughness, as shown in **Figure 6**. Besides, some regions with full coating coverage are observed in both the unmachined and machined surfaces of the coated substrates, see **Figures 9d** and **10d**.

**Figure 9.** SEM micrographs of the phosphate-coated unmachined substrate.

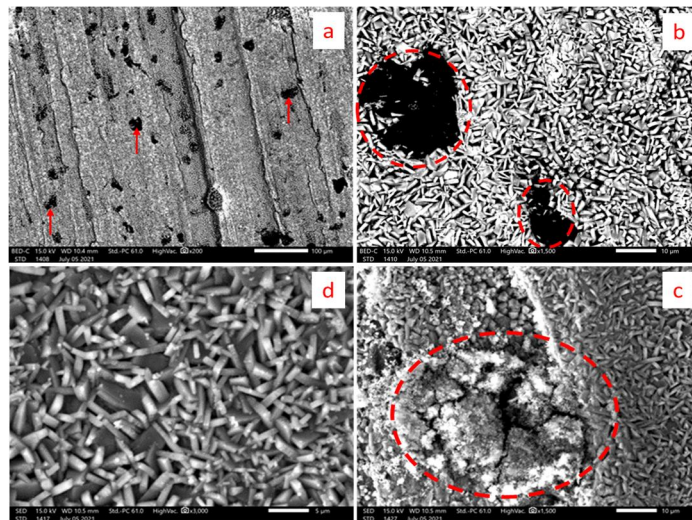
**Figure 10.** SEM micrographs of the phosphate-coated machined substrate.

and size of the phosphate coating. The unmachined surface with the as-cast skin shows spherical phosphate coating crystals (**Figure 9d**) while the machined surface reveals a long tetragonal crystal structure (**Figure 10d**). The average phosphate crystal size was measured and provided in **Table 3**. The crystal size of the unmachined phosphate-coated surfaces ranges from 0.633  $\mu\text{m}$  to 3.182  $\mu\text{m}$ , while that of the machined surfaces ranges from 0.828 to 6.240  $\mu\text{m}$ . In summary, it is apparent from this investigation that, the presence of graphite and foreign inclusions adhesion on the substrate surfaces damages the phosphate coating. Also, rough surfaces with cracks lead to poor phosphate coating. The phosphate coating sizes and morphology are influenced by the surface characteristics of the coated substrate.

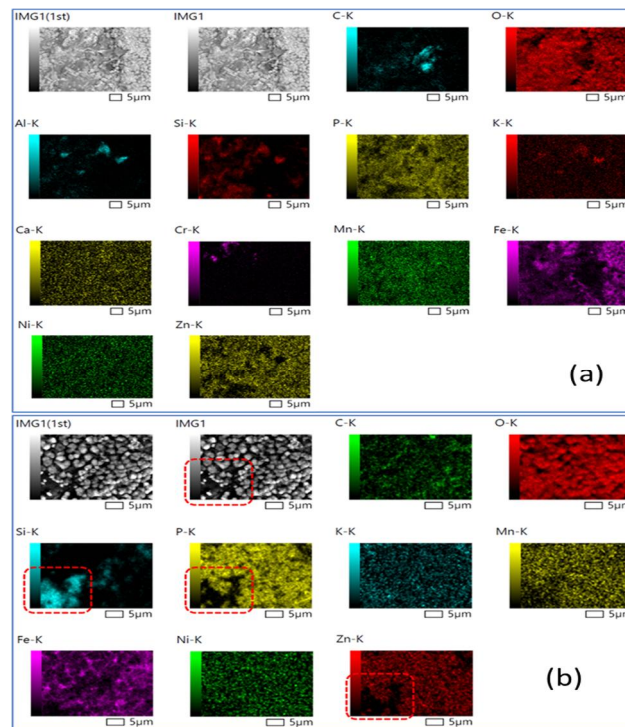
**Figures 11** and **12** represent the SEM-EDS elemental mapping of the phosphate-coated unmachined and machined substrates. It is indicative from **Figures 11** and **12** that, the regions with poor phosphate coating are rich in carbon, silicon, potassium, and aluminium. The presence of these elements suggests the existence of sand inclusions on the as-cast surface of the substrate (**Figure 11**). In **Figure 12b**, the regions with poor coating are the areas with graphite phases. It is also observed that the nature of the substrate surface affects the shape

**Figure 11.** SEM-EDS elemental mapping of the phosphate-coated unmachined substrate.

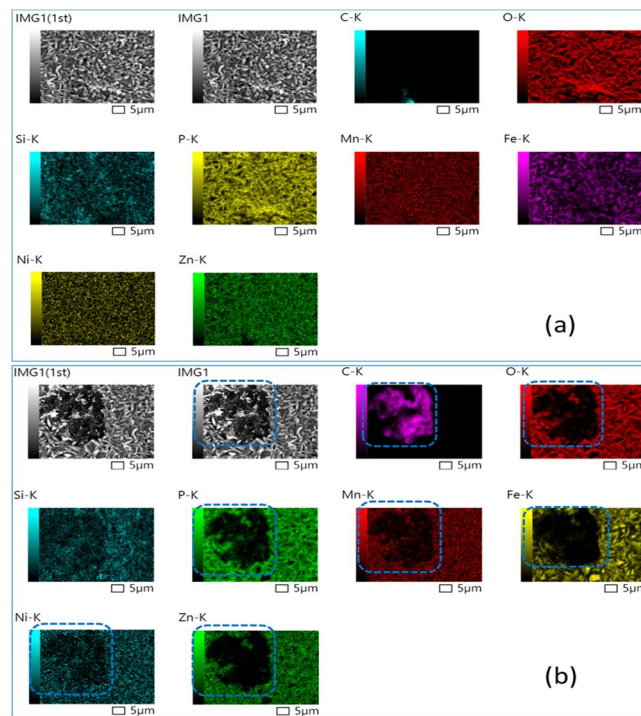
**Figure 12.** SEM-EDS elemental mapping of the phosphate-coated machined substrate.

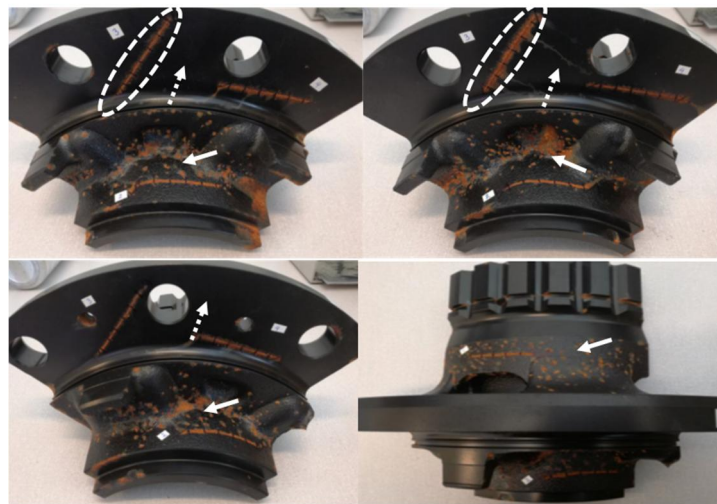
**Figure 14** shows the pictures of some of the coupon specimens after the corrosion test. The inner corners of the unmachined surface of the wheel hubs were much more corroded than the outer surfaces of the unmachined region. The machined surfaces of the components are free of rust, implying excellent corrosion resistance. The corrosion performance of the coatings on the surface of the wheel hubs after their exposure to the corrosive medium was evaluated by the ASTM D1654 standardized procedure<sup>[18]</sup>. This standard describes the scribing of coated test coupons into the substrate from the coating layer using one of several scribe tools. Analyzing the corrosion that occurred close to the scribed line allows for a qualitative evaluation of the coating's corrosion resistance. An estimation of the coating's corrosion resistance can be made using this

method, but it does not reveal anything about the mechanisms that prevent corrosion<sup>[19]</sup>. The coated substrate is intentionally scribed (damaged) to expose the coating/metal interface to corrosive media to assess the function of passivating agents (if any), the level of coating adhesion to the substrate, and the surface state of oxides on which the coating is applied<sup>[19]</sup>. Threadlike filaments may emerge when scribes are exposed to corrosive environments. The developed filaments can be assessed and scored according to the ASTM D1654 technique for corrosion testing of metallic and other inorganic coatings on metallic surfaces. In addition, the general corrosion resistance of the coated-wheel hubs exposed to the accelerated cyclic corrosion test procedures was evaluated and rated according to the ISO 4628-3 standard<sup>[17]</sup>. Based on these standard methods, the corrosion resistance of the coated substrates was examined and scored as presented in **Table 4**. For this component to pass the corrosion resistance requirements, the width of the scribe lines after post-exposure to corrosive environments should be less than or equal to 8 mm. The general corrosion resistance of the entire surface of the coated substrates after the corrosion test is rated and must be scored a grade less than or equal to Ri 1 according to the ISO 4628-3 rust rating scale. As observed in **Table 4**, all five samples tested passed the scribed coated substrate corrosion resistance requirements. The coated machined surfaces of the wheel hub substrates also passed the general corrosion resistance requirements, but most of the unmachined surfaces of the coated substrate did not fulfil the requirement. In general terms, the corrosion resistance of the coated unmachined surfaces was disapproved according to the application requirements of the component. The poor corrosion resistance of the unmachined surfaces of the coated substrate could partly be influenced by the characteristics of the surface and the coating process parameters. However, to improve the surface properties of the unmachined areas, the cast component should be properly shot-blasted to remove any adhere foreign materials on the as-cast skin surface, which may hinder the adherence of the coatings on the substrate surface.

**Figure 14.** The appearance of the sample coupons after six weeks of accelerated corrosion test, where the solid and broken lines represent the unmachined and machined surfaces, respectively, and broken circles indicate the scribed lines.

This investigation examined the surface characteristics of machined and unmachined surfaces of ductile cast iron wheel hubs. The influence of these surface imperfections on the Zinc phosphate coating and the subsequent corrosion resistance was assessed and rated according to the standard procedures. Surface analysis of the machined and unmachined hubs revealed the existence of graphite and sand bonding on the substrate surface, possibly affecting the phosphate coating. Foreign material on the as-cast surfaces and cracks caused poor phosphate coating. The average phosphate coating crystal size is 1.742  $\mu\text{m}$  and 2.578  $\mu\text{m}$  for the as-cast and machined substrates, respectively. The substrate surface roughness influences the size and shape of the phosphate coating crystals. It is recommended that the as-cast surface should be properly cleaned to remove sand bonding on the as-cast skin. Surface cracks on the machined surface should be minimised to ensure perfect phosphate coating. Generally, the corrosion resistance of the coated unmachined surfaces was disapproved based on the application requirements of the wheel hubs. The poor corrosion resistance of the unmachined surfaces of the coated substrate was attributed to the influence of the substrates' surface characteristics on the coating processes. The cast surfaces should be properly shot-blasted to remove any adhere foreign materials on the cast skin to enhance the adhesion of the phosphate coatings on the substrate surface.
